**BUSHFIRE TEST ON A WINDOW  
ROLLER SHUTTER**

**Report number FSZ 1456**

**CROCI AUSTRALIA PTY LTD**

Part 8.1-2007: Tests on elements of construction for buildings exposed to simulated bushfire attack – Radiant heat and small flaming sources.

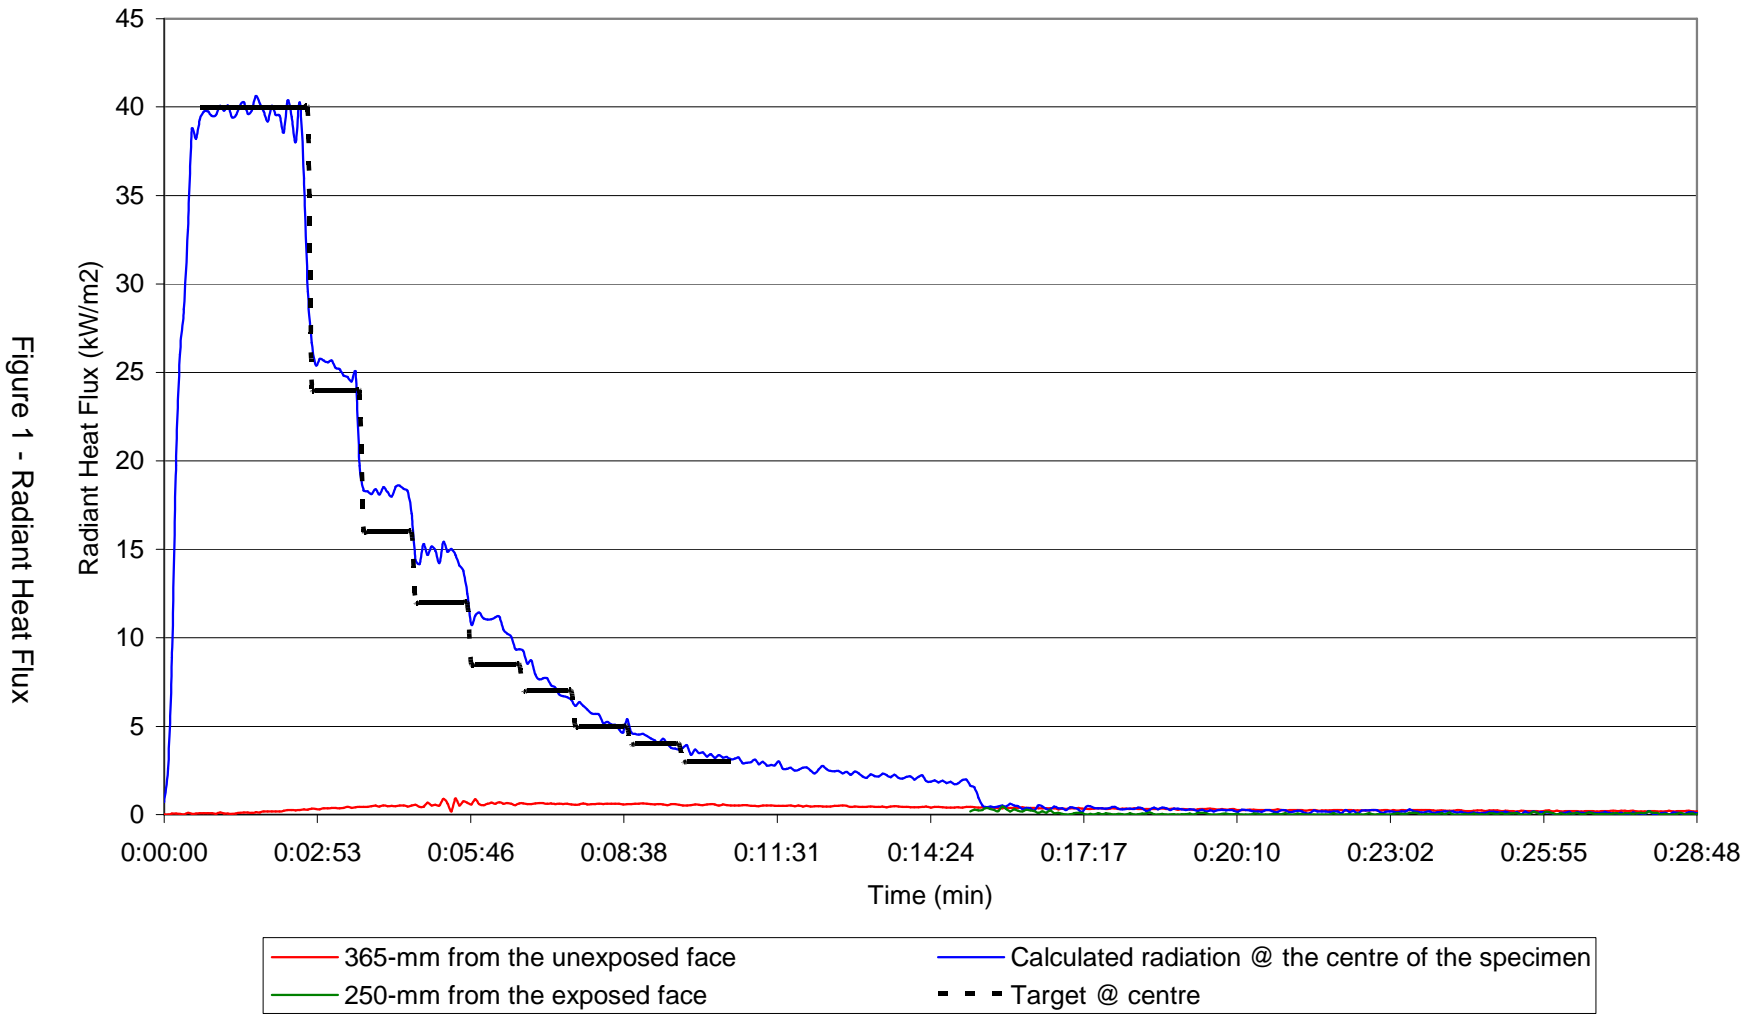
Figure 1 shows the curves of target and incident radiation versus time and the actual curves of received radiation at 365-mm from the unexposed face and 250-mm from the exposed face versus time recorded during the test period.

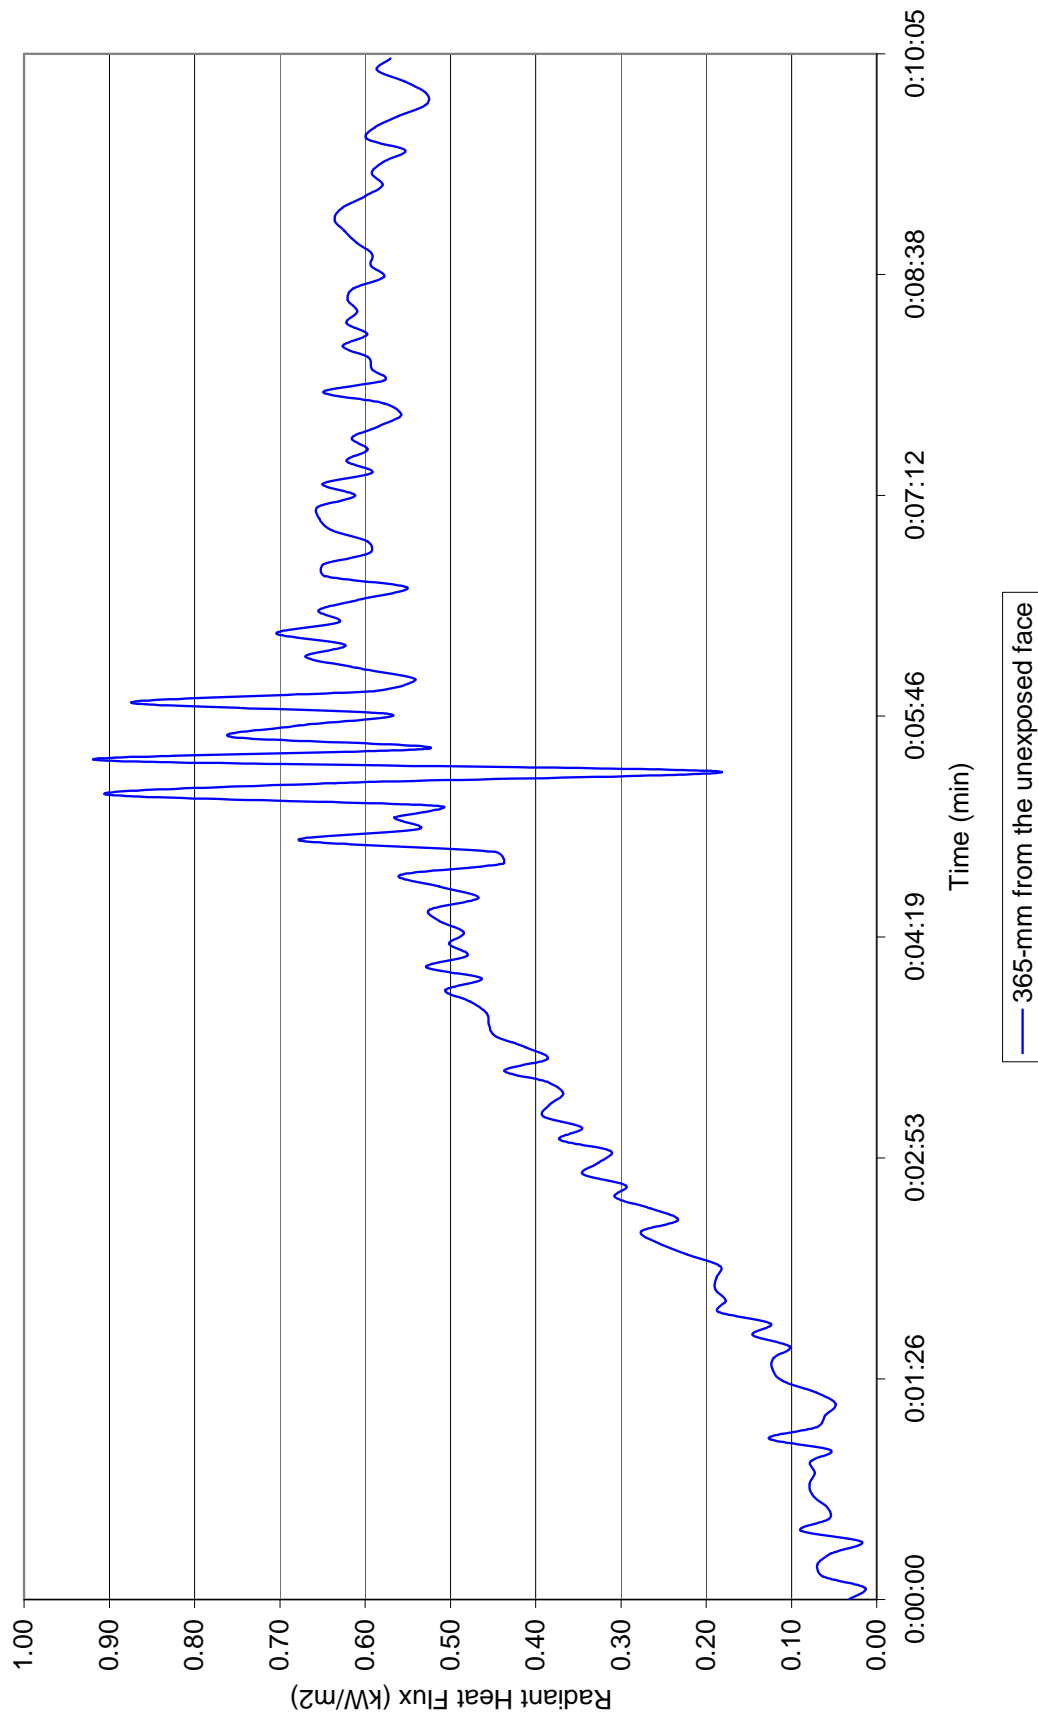
Figure 2 - Radiant Heat Flux received @ 365-mm from the unexposed face

Figure 2 shows the curve of received radiation versus time at 365-mm from the unexposed face of the specimen.

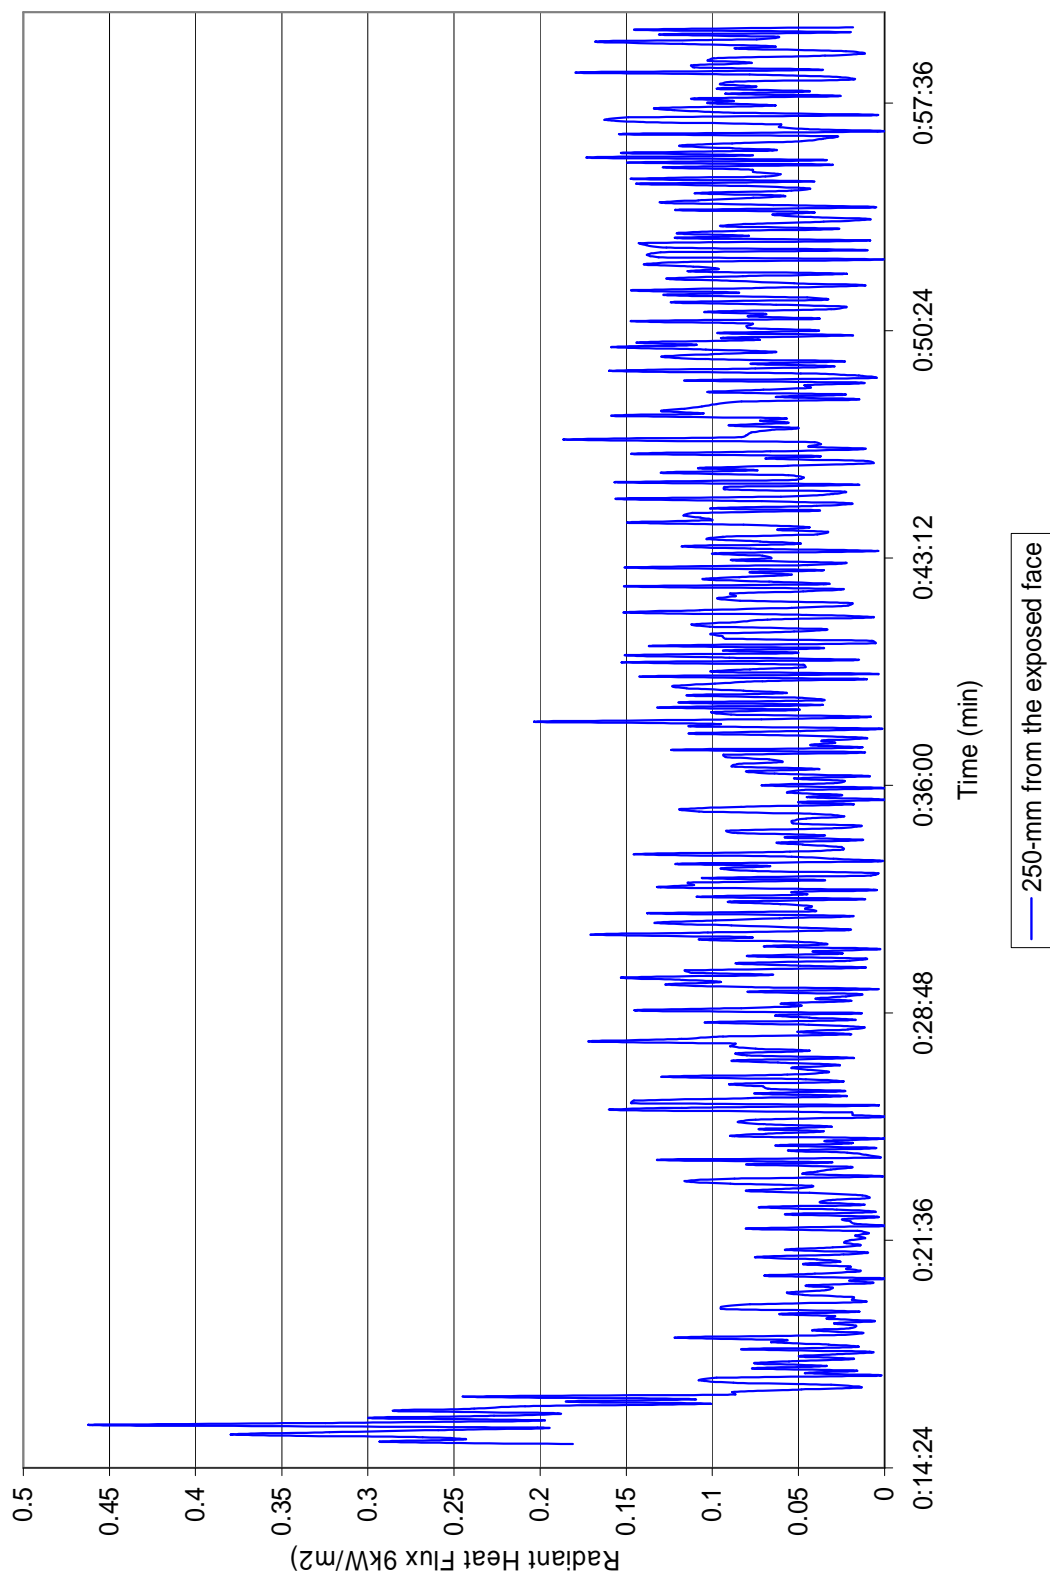
Figure 3 - Radiant Heat Flux received @ 250-mm from the exposed face

Figure 3 shows the curve of received radiation versus time at 250-mm from the exposed face of the specimen.
